# 12 Fifth Avenue

Raker Support System | 2023

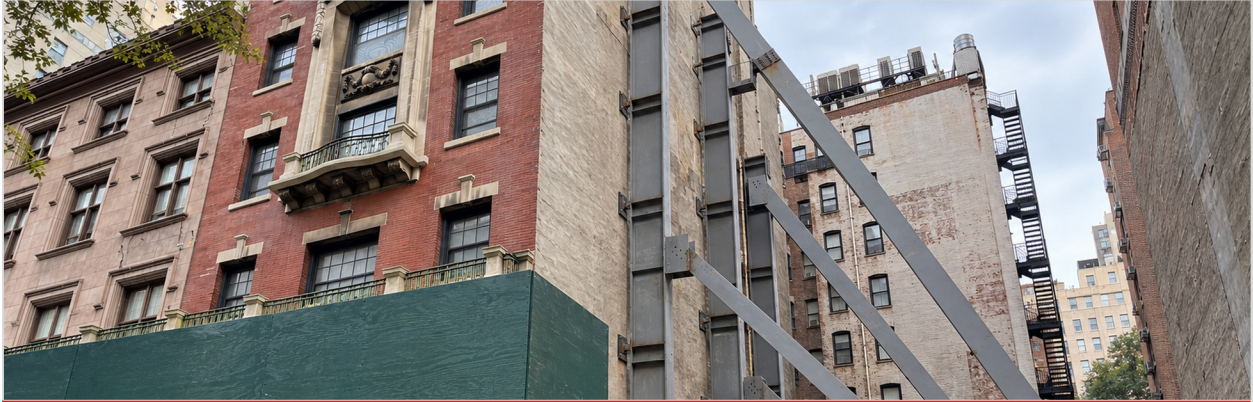
STRAAM installed 12 strain gauges on the raker supports on Aug 22, 2023 and recorded a roughly two-week pre-drilling baseline. Monitoring tracked strain during drilling; an empirical thermal adjustment helped interpret temperature effects. A monitoring site displayed readings near real time.

The monitored supports showed no sudden changes during drilling. Over time, readings revealed gradual shifts, giving the team an ongoing view of how the supports responded as excavation progressed.
