# Lead-in Jetty

## Continuing Integrity Monitoring

The lead-in jetty for the port is used by ships to approach a lock that allows them to enter the port. The lead-in jetty is composed of a series of steel cylinders filled with sand. The port believed that an instability was developing and that some of the cylinders were subject to corrosion. STRAAM made on-site measurements, conducted a finite element study and identified areas of the jetty that was compromised. Subsequently, the cells were repaired and STRAAM returned to assess the efficiency of the repairs. It was shown that they had been very effective

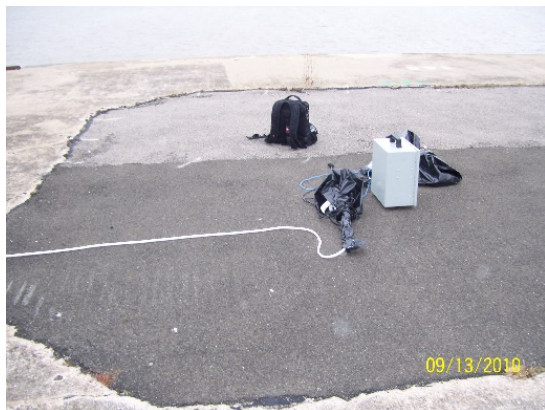
STRAAM Group has developed the SKG (Structurocardiograph). For this set of measurements the mark 1 SKG was used with internally mounted accelerometers. On site personnel now use a mark 2 SKG to make measurements themselves and then remove a data card and send the information to the STRAAM headquarters in New York City. The new arrangement allows for the collection of more data coupled with lower costs.
