Dolphin Analysis

Structural Identification and Risk Analysis

Companhia Vale do Rio Doce

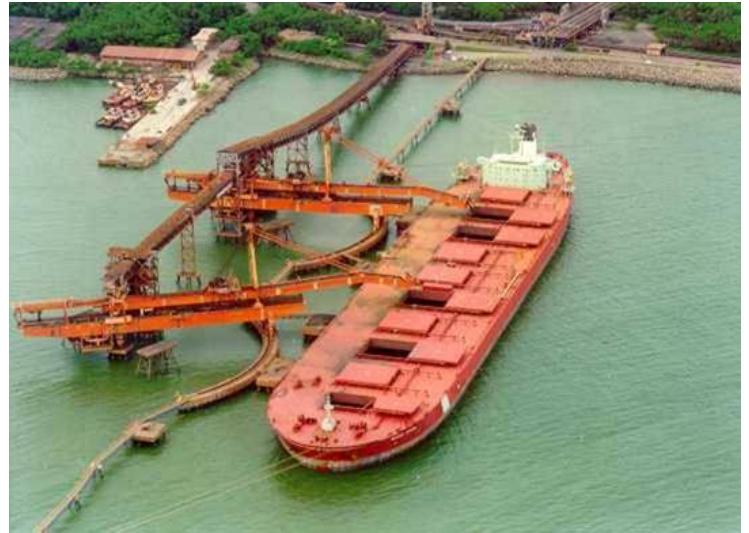
The company had been running the port facility for more than 30 years and was interested in knowing if there were any problems with the aging facility. The facility includes equipment for transporting and loading minerals onto very large barges. The loading mechanism is protected from ship impact by a series of dolphins. STRAAM not only investigated all of the land based equipment, but also investigated the stability of the dolphins. One of the dolphins was found to have a partial foundation failure.

The client was reassured about the integrity of the large part of the structure. Additionally, with the foundation failure identified, resources could be dedicated to dealing with this small-scale problem. The rest of the equipment was scheduled for another inspection after 5 years of operation.

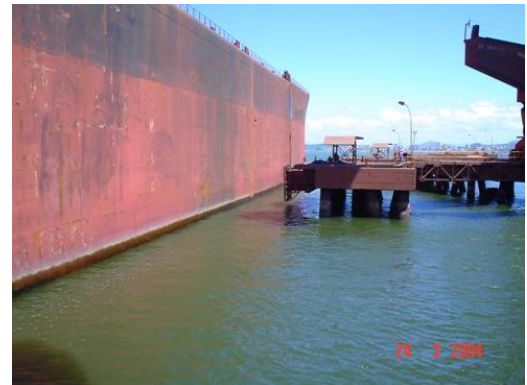
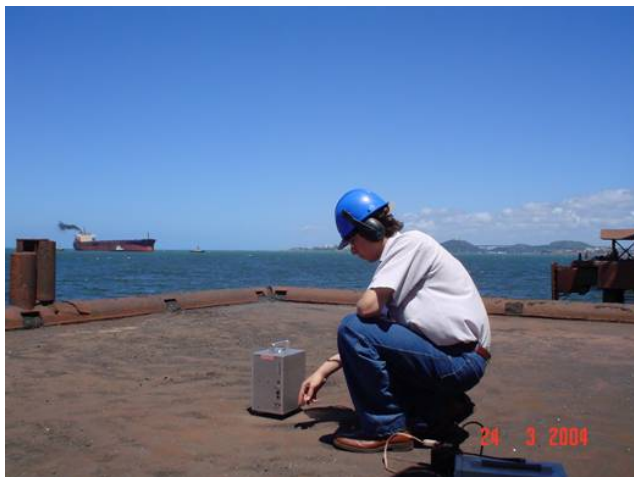
STRAAM Group personnel were operating with the help of a Brazilian Geotechnical company. The servo-accelerometers (later used as the basic work-horse for STRAAM) were housed in a dedicated box and measurements of the response to a ship impact were obtained.
