The effect of post-tensioning force magnitude and eccentricity on the natural bending frequency of cracked post-tensioned concrete beams

To cite this article: D Noble *et al* 2015 *J. Phys.: Conf. Ser.* **628** 012047

D Noble¹, M Nogal¹, A J O'Connor¹ and V Pakrashi²

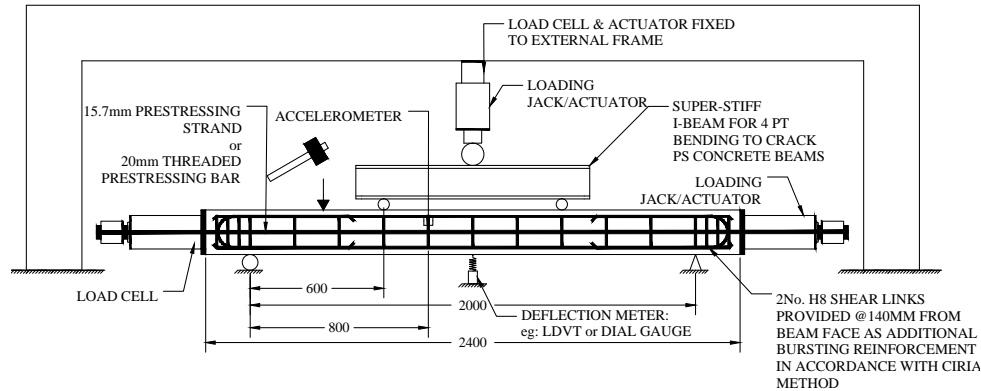
Figure 1: Experimental set-up.

9No. 150 wide x 250 deep PS beams with following PS bar/strand eccentricities:
 $e = -52, -39, -26, -13, 0, +13, +26, +39, +52$

11No. PS Load testing levels:
 $P = 0, 20, 40, 60, 80, 100, 120, 140, 160, 180, 200$ kN

flexural cracks formed in the area of high moment, between the span of the spreader beam, whereas diagonal shear cracks formed in the areas between the end of the spreader beam and the supports. Following cracking, dynamic impact testing was conducted on the beams. Figure 1 shows the experimental set-up. An accelerometer was placed 800mm from one of the supports as shown, enabling the first three modes of vibration to be captured. Three strain gauges were placed equi-distant between the support and mid-span, in order to capture the mode shapes of vibration. The beam was struck ten times at each strain gauge location using an impact rig assembled in the laboratory. This ensured repeatability of the experiment and enabled the error in the estimation of the frequencies to be calculated. This experimental procedure was then repeated at incremental values of post-tensioning load, as outlined in Figure 1. The post-tensioning load was applied using a 15.7mm Freyssinet post-tensioning strand, secured either side of the 300 ton loading jacks as shown. The different straight profiled strand eccentricities are also outlined in Figure 1. A similar testing procedure was applied to the uncracked beam sections and has been outlined in previous works by the same authors [17].

Following dynamic impact tests in the lab on nine uncracked post-tensioned concrete beam sections, which have been described previously [17], 4-point bending was applied to each beam as outlined in Figure 1. The individual beams differed in that they had different straight profiled post-tensioning strand eccentricities. The transverse load was applied incrementally and the crack patterns were observed at different values of load application. The loading increments and yield moment for Beam 1 ($e=0\text{mm}$) are outlined in Table 1. First, second and third cracks were identified by visual inspection only, and were not determined scientifically.

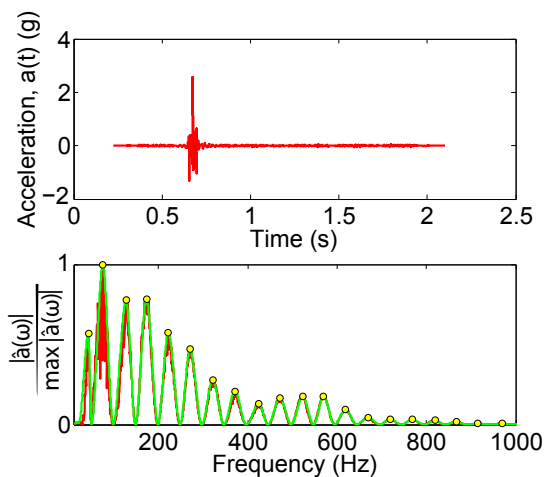
Figure 2: Structural dynamic response of cracked beam for non-fully prestressed case, Beam 1, $e=0\text{mm}$

Figure 2 and Figure 3 show the results of two processed signals. The higher modes are now intelligible. A peak picking algorithm is invoked to determine the natural frequencies of the system. Figure 2 shows an accelerometer response signal of a cracked beam for zero post-tensioning load, indicating a structural dynamic response of the cracked beam for a non-fully prestressed condition, in which the cracks are open. It is evident that the structural response of the non-fully prestressed condition is complex. The fundamental mode, in this case contributes most to the response, but its contribution is not dominant. The contribution of the other modes is relatively similar.

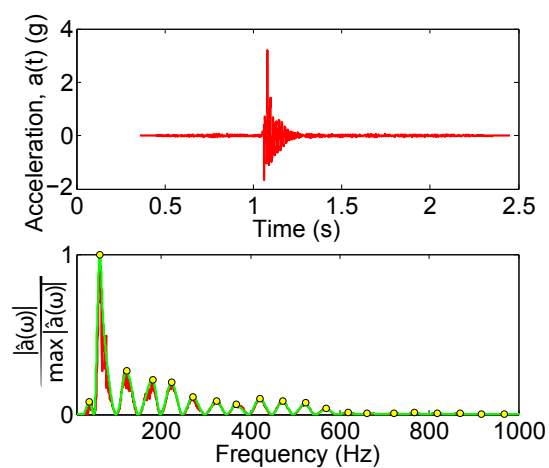
Figure 3: Structural dynamic response of cracked beam for fully prestressed case, Beam 1, $e=0\text{mm}$

Figure 3 shows an accelerometer response signal of the same cracked beam for a post-tensioning load level of 180kN, indicating a structural dynamic response of the cracked beam for a fully prestressed condition. Here, the dominance of the first mode of vibration is evident. The beam, when fully prestressed, behaves monolithically and vibrates as one entity rather than a series of individual cracked entities, and hence the dominance of the first vibration mode returns. This response is in line with the response of the uncracked ‘virgin’ beams.

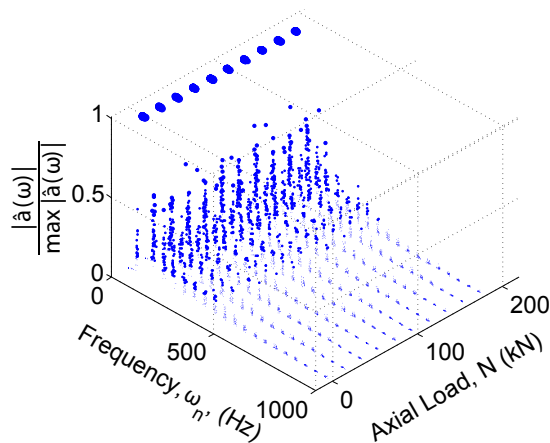
Figure 4: Rel. Modal Amp. Uncracked Beam 1, $e=0\text{mm}$

Figure 4 shows the structural dynamic response of Beam 1 ($e=0$) in its uncracked condition. The dominance of the first mode of vibration is evident in this case, since the relative modal amplitude of the fundamental bending mode accounts for a large proportion of the modal mass of the structure. Figure 5 shows the structural dynamic response of Beam 1 in its cracked condition. In this case, the dominance of the first mode of vibration is not clear. The structural dynamic response is much more complex and the contribution of the higher modes of vibration are clearly far more significant in the cracked case. This is evident up to a certain threshold value of post-tensioning force. The dominance of the first vibration mode again becomes apparent in the cracked case when the post-tensioning force causes the structure to behave as one monolithic structure rather than a series of cracked entities. This is the fully prestressed condition. In this case, for Beam 1, $e=0\text{mm}$, it was identified to be at a value of 160kN.

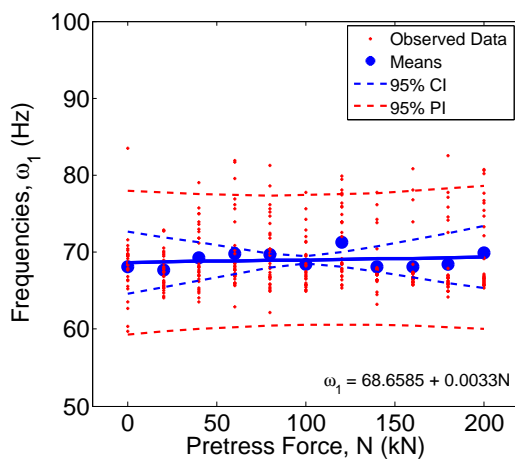
Figure 6 and Figure 7 show regression analysis of fundamental frequency versus post-tensioning load for the same beam in its uncracked and cracked states. From the regression analysis of the uncracked case in Figure 6, no statistically significant change in fundamental

frequency with increasing post-tensioning force can be observed, as previously reported [17]. From first glance at the simple linear regression analysis of the cracked beam case, an overall decreasing trend in fundamental frequency versus post-tensioning load is observed. However, when analysed in conjunction with Figure 5, it becomes apparent that there are two distinct trends in the data. For the non-fully post-tensioned case (0-160kN), the structural dynamic response is complex, the error in the estimation of the natural frequency is high, the structure behaves dynamically as a series of independent vibrating entities and a decreasing trend in fundamental frequency is observed. However, at a threshold post-tensioning load level and upward (160-200kN), the dominance of the first vibration mode returns, the error in the estimation of the fundamental frequency decreases, the structure begins to behave monolithically again, and an increasing trend can be observed for the final 3 data points. This increasing trend, has been widely reported for cracked beam sections [5, 8, 10, 11, 12, 13, 14, 15], however, is not observed for uncracked beam sections [4, 15, 17]. The stiffness of the section is increased by increasing the prestressing force due to crack closure, and the second moment of area moves from the cracked to the uncracked value.

Figure 6: Regression analysis of fundamental frequency vs. post-tensioning load; uncracked case.

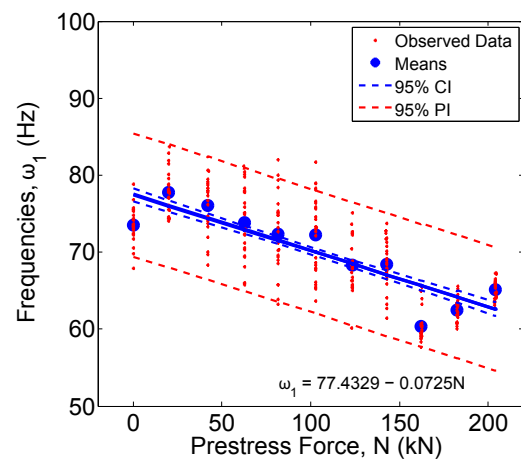
Figure 7: Regression analysis of fundamental frequency vs. post-tensioning load; cracked case.

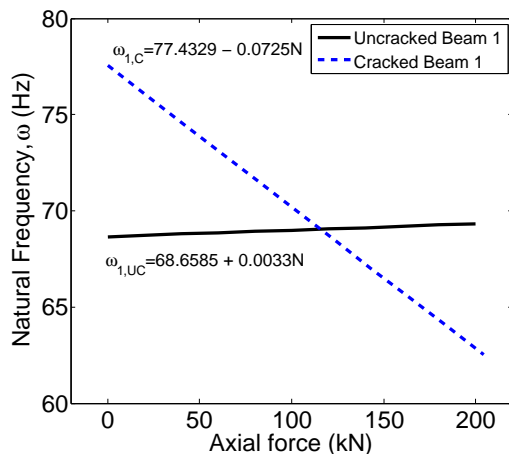
Figure 8 shows the comparison between the simple linear regression models for the cracked and uncracked beam cases. As discussed previously, this is not strictly a reasonable comparison as two different trends can be observed in the cracked beam case. The initial fundamental frequency for the cracked beam is higher to begin with, which is counter-intuitive. If it is considered that the beam in its damaged state behaves as a series of different vibrating cracked entities rather than as one monolithic structure, then the span length of each individual vibration entity is significantly reduced. Since the span length is a denominator in the equation for the prediction of natural frequency for simply supported beams, this makes intuitive sense. This span length increases as the post-tensioning force increases and more and more structural cracks are closed, meaning the measured frequency decreases. On the other hand, when the beam begins to vibrate again monolithically, the structural dynamic response becomes less complex and the fundamental mode dominates, an increasing trend is observed in the frequency with increasing post-tensioning force. At the threshold value of post-tensioning force, the span length reaches its original value. From this point onwards, as shown in Figure 9 an increasing trend in fundamental frequency is observed, and this is attributed to the gain in geometric stiffness due to crack closure, in accordance with previous research works [5, 8, 10, 11, 12, 13, 14, 15].

Figure 8: Regression comparison between cracked and uncracked beam cases.

Table 2 shows the statistical regression parameters - intercept parameter ($\alpha_{0,iuc/c}$), slope parameter ($\alpha_{1,iuc/c}$), standard error, t-values and 95% confidence intervals when regressing ω_1 on N for Beam 1, $e=0$ ($i = 1$) in its cracked (c) and uncracked (uc) case. The corresponding linear regression equations are obtained by substituting into Equation 1. Table 2 should be read in conjunction with Figure 8 for completeness.

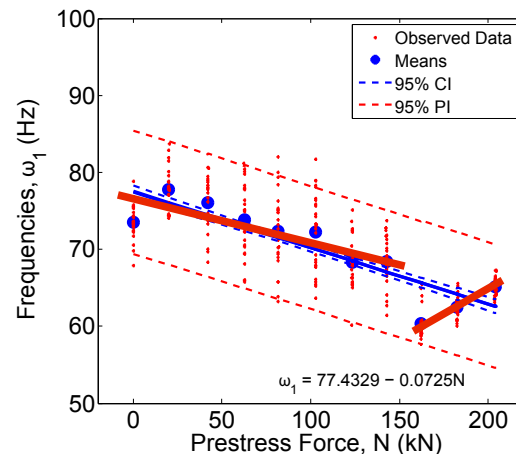
Figure 9: Evidence of the two trends present in the data.
